Hammock Oaks

FIELD REPORT

April 2024

FIELD DIVISION REPORT Paul Winkeljohn Phone 954-721-8681

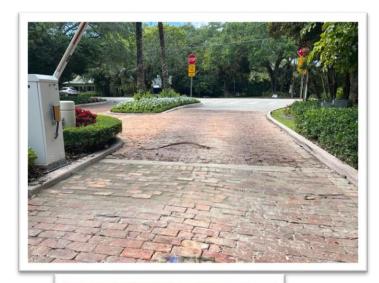
• Entire brick system is shifting. Will need to be reset.

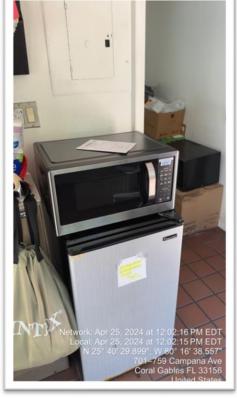
• Microwave was replaced at the Guardhouse.
