Old Cutler Bay

FIELD REPORT

September 2025

OLD CUTLER BAY - Barrier Arm Operator Replacements 1.2024 Summary

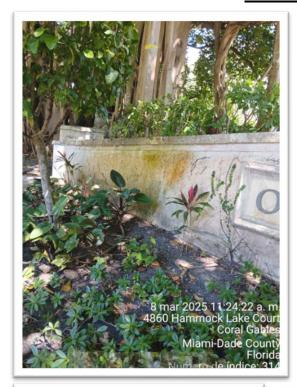
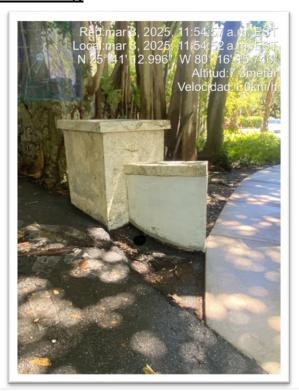
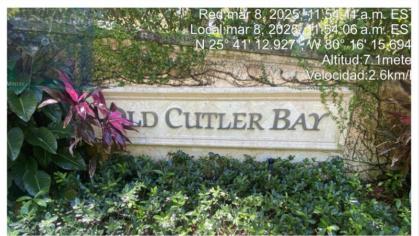
• Monuments and sidewalks were pressure cleaned by First In Property Solutions.

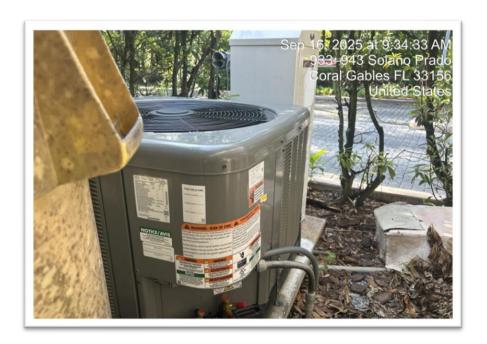
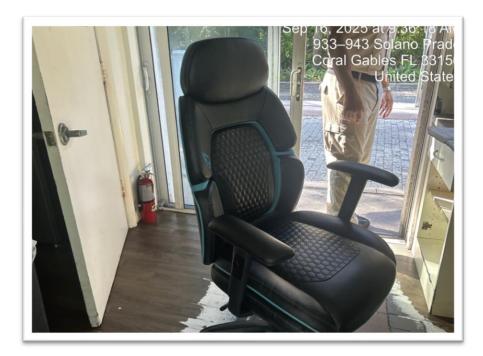
- AC unit was replaced.
- Chair was replaced by First In Property Solutions.
